# Manhole Inspection Summary

Manhole # S41AA\_070MH

Insp Date: **11/28/07 2:47 PM**

**Location** Address: **e.monument st**

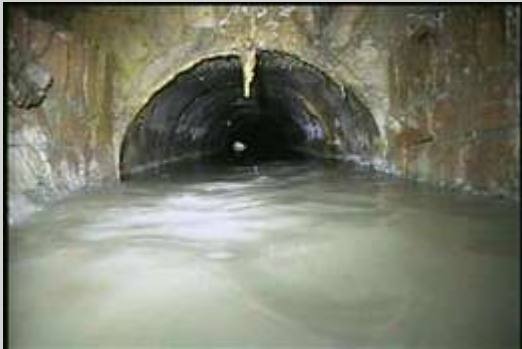
12 O'Clock Outflow

18 in. Circular Gravity Sewer  
Pipe Out @ 12 O'Clock

Pipe Material: **Clay** ☐ Pipe Lined

Invert Depth: 17.00 (ft.) Flow Characteristics: **Fast**

Deposits: ☒ None ☐ Mud ☐ Sludge ☐ Debris ☐ Grease

Infiltration: **None** Pipe Seal Cond: **Unknown**

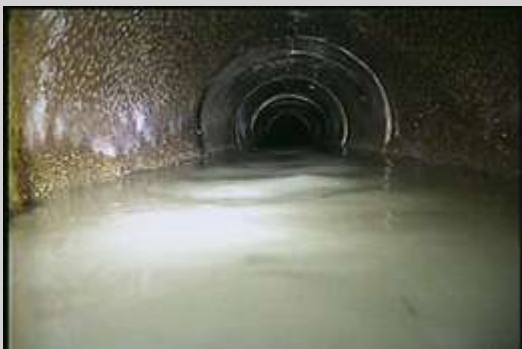
6 O'Clock Inflow

18 in. Circular Gravity Sewer  
Pipe In @ 6 O'Clock

Pipe Material: **Clay** ☐ Pipe Lined

Invert Depth: 16.90 (ft.) Flow Characteristics: **Fast**

Deposits: ☒ None ☐ Mud ☐ Sludge ☐ Debris ☐ Grease

Infiltration: **None** Pipe Seal Cond: **Unknown**

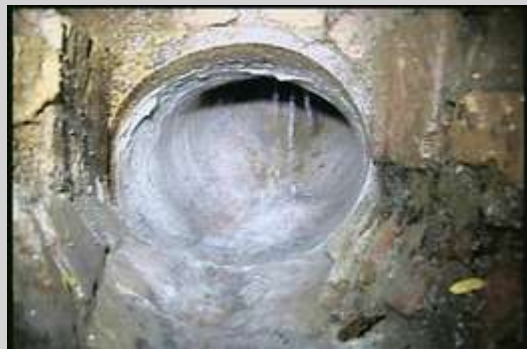
9 O'Clock Inflow

8 in. Circular Gravity Sewer  
Pipe In @ 9 O'Clock

Pipe Material: **Clay** ☐ Pipe Lined

Invert Depth: **16.30** (ft.) Flow Characteristics: **Slow**

Deposits: ☒ None ☐ Mud ☐ Sludge ☐ Debris ☐ Grease

Infiltration: **None** Pipe Seal Cond: **Unknown**
